GLENDOLA RESERVOIR

NJ 00096

PHASE 1 INSPECTION REPORT NATIONAL DAM SAFETY PROGRAM

April, 1979

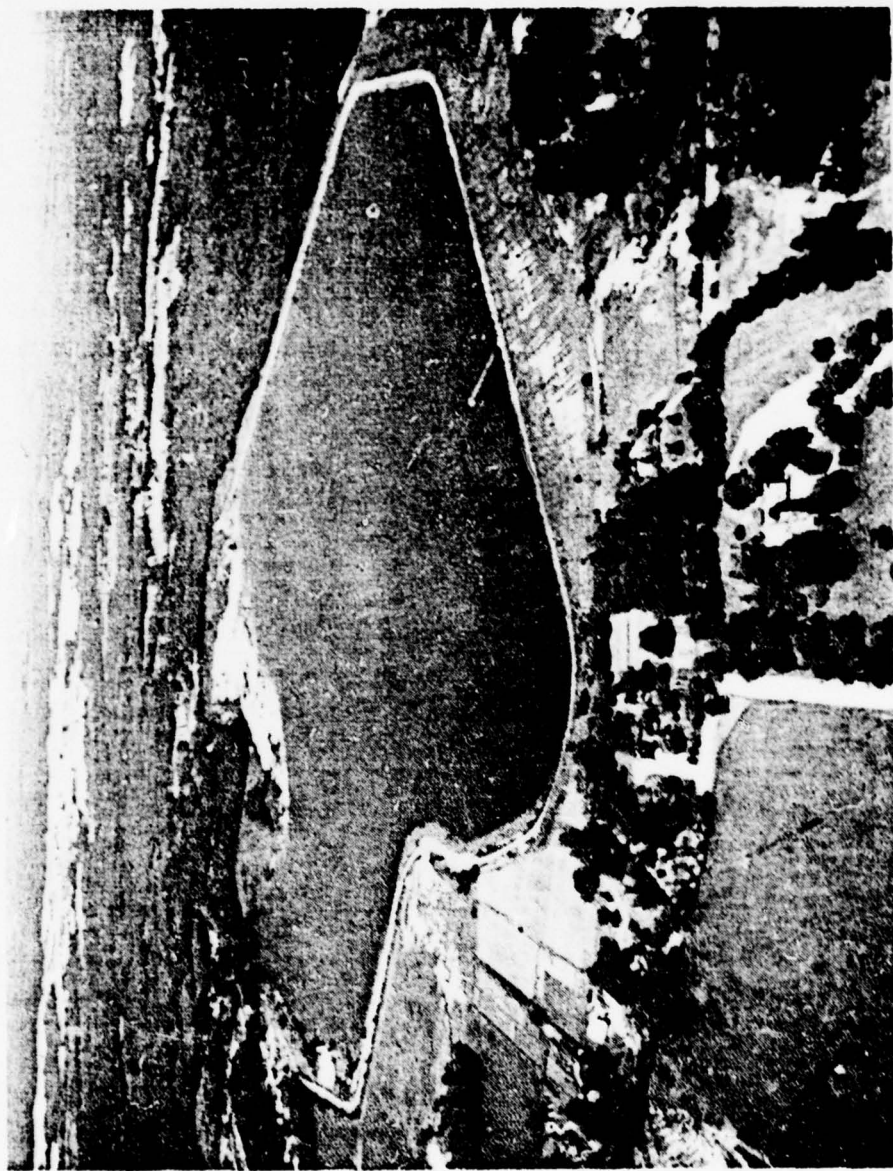
OVERVIEW OF GLENDOLA LAKE DAM

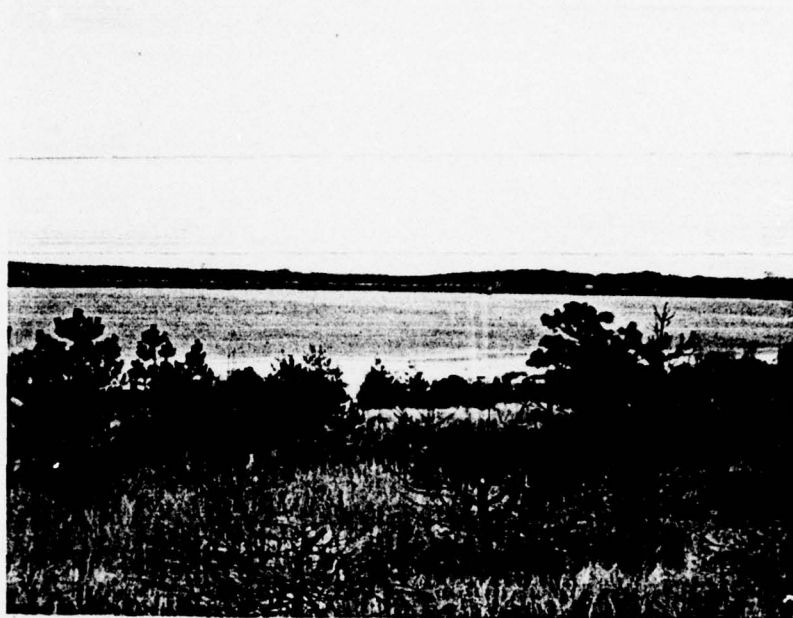
Overview of dam

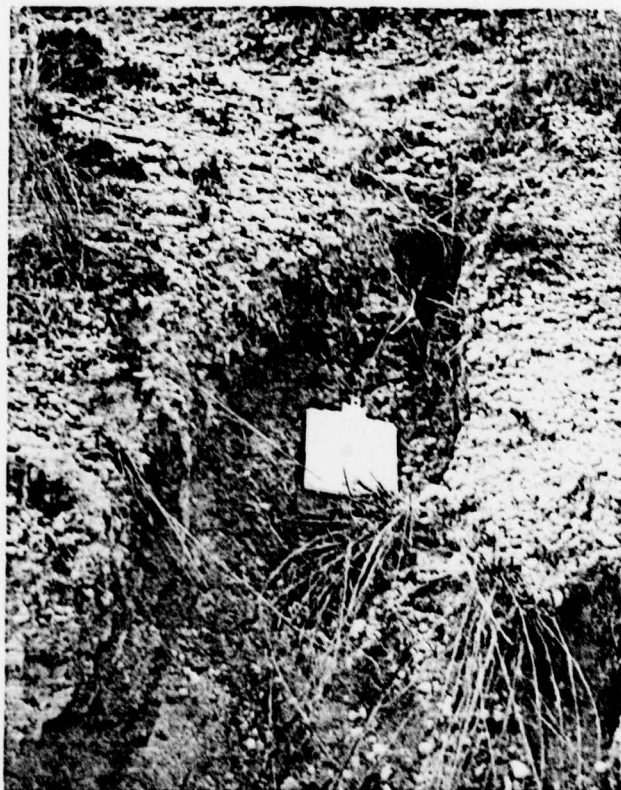
The major portion of the horseshoe-shaped embankment lies just west of Gully Road and is over 60 feet high in the vicinity of the Robins Swamp Brook channel. The embankment extends along the northeast side and the remainder of the reservoir is bounded by the natural high ground. The reservoir side slope varies between 2:1 and 3:1 and is protected with riprap, although only the top few feet could be observed. The riprap appears in good condition with only minor subgrade erosion. There is no riprap on the downstream slopes but concrete and macadam have been placed at the northwest corner, apparently to retard erosion. The dam crest is 20 feet wide and stabilized with a 6" gravel roadway which is in good condition. The embankment backslopes have a fairly uniform cover of grass and secondary growth near the toe, but in numerous areas where the grass has not taken, there are erosion gullies which are quite severely incised. There are numerous rodent burrows on the slopes and erosion gullies are scoured out immediately down the slope, apparently caused by the burrow openings.

Erosion of downstream slope of dam

- a. Regrade the eroded backslopes and fill the burrow holes.
- b. Overseed the slopes with consideration given to supplying a different type of ground cover which might take better hold on the dry arid slopes.
- c. Continue study and analysis of piezometer readings to evaluate whether the continued cleaning and/or backflushing of the relief wells is sufficient in the long-term aspects of controlling the seepage at the downstream toe. Quite possibly, new wells or an extension of the zone protection might be indicated in the analysis.

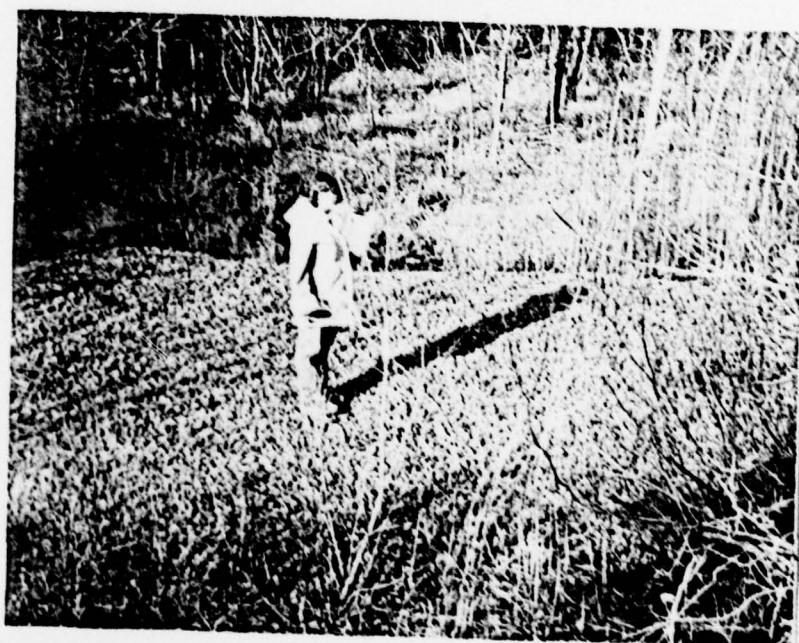
Boiling occurred at a point approximately
100' from toe of westerly portion of
embankment. Condition has been
corrected.

Location of boil

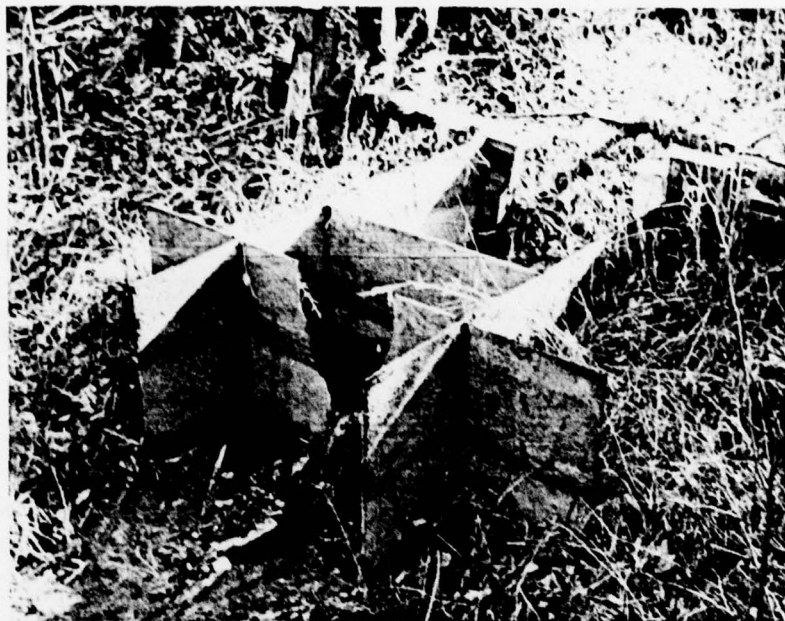
V-nched weir measuring toe drain flow
